DELAWARE RIVER BASIN

EVANS POND DAM

PHASE I INSPECTION REPORT NATIONAL DAM SAFETY PROGRAM

NJ 00394

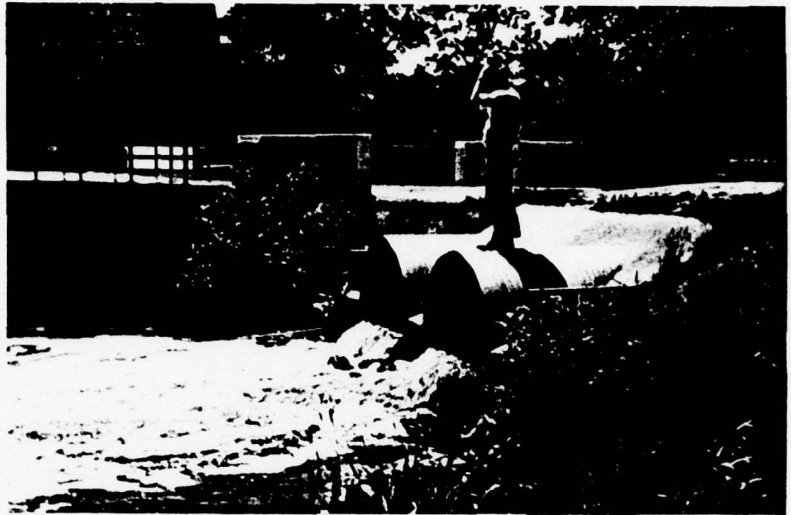
Discharge of Sluices
June 1978

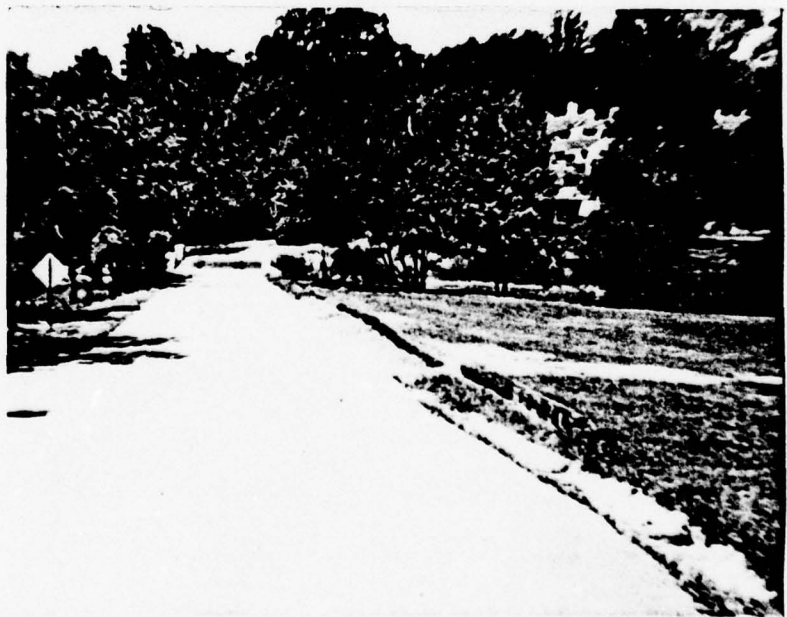
View West towards bridge
June 1978
